## DESIGN AND CHARACTERISTICS

### OF A 100 KILOVOLT HYDROGEN THYRATRON TUBE

H. E. Krefft, H. Austad, and A. E. Gordon

International Telephone and Telegraph Corporation  
Electron Tube Division, Easton, Pennsylvania

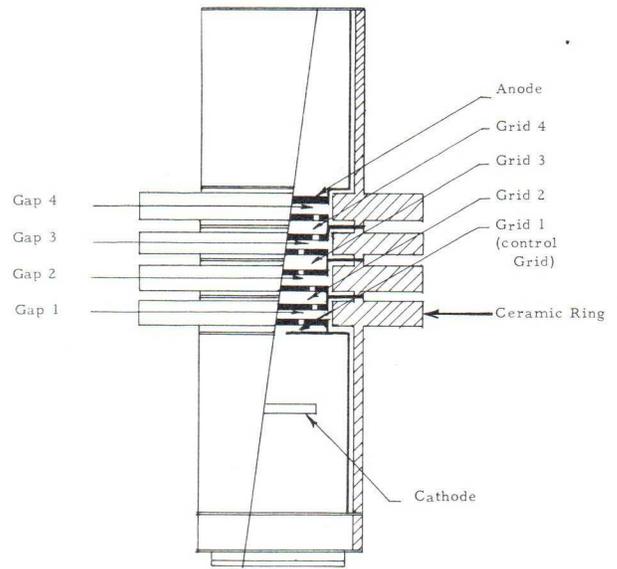
Figure 1: 100 KV - 10 KW Hydrogen Thyatron Tube. Basic design of a four-gap Tube.

The grid-envelope structure of a four-grid\* tube with four gaps consists of three planar gradient grids and four ceramic envelope rings which are brazed to the grid flanges. Voltage breakdown between seals is inhibited by internal and external extensions of the rings which internally follow the grid outlines with a small clearance. Metallic deposits originating in the gaps are formed on the cylindrical surface of the extension and are prevented from forming a continuous conducting layer between seals.

In a short grid structure of this kind, the seals with the ceramic envelope of the closely spaced grids are at a small distance from each other which is determined by the length of the grid and the size of the gap. Voltage breakdown between adjacent seals, both inside and outside the tube, through which high voltage operation would be greatly limited, was overcome with the design illustrated by Figure 1. As it provided an effective protection of gaps and seals, it was used without change on 30 tubes of this type which were made with three, four and six gaps and served as experimental vehicle for this investigation.

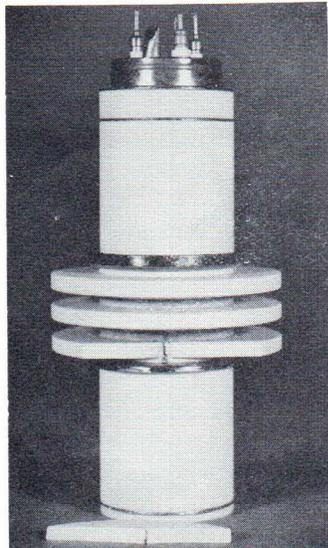
Figure 3: Three-Gap Tube damaged by voltage breakdown through the envelope ring.

Unexpectedly short lives were experienced in the beginning when operation at the specified ratings of 100 KV, 10 KW, 1000 pps and a  $P_b$ -Factor of  $20 \times 10^9$  was attempted. The anode plate was found to be strongly eroded at the impact areas of the discharge, and high voltage breakdown through the ceramic envelope extension at the anode gap became a typical cause of failure. These defects are illustrated by the photographs in Figures 3 and 4.

In spite of these measures, tube life still was terminated by voltage breakdown through the ceramic envelope ring, which resulted in a leak. In most tubes this defect was caused at the external ceramic extension of the anode gap, in one tube internally, and in two other cases the gap next to the anode gap was involved or the only one affected. Improvement of this condition was attempted by avoiding high electrical field strength at the seals, and by increasing the thickness of the external extension of the envelope ring.

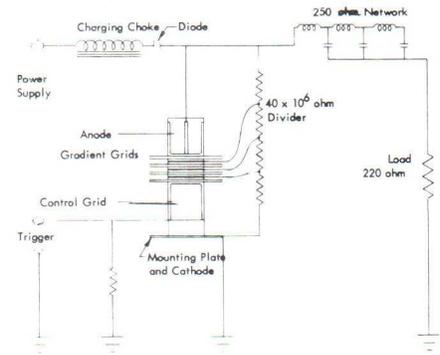
The instrumentation included a pulse transformer for viewing the current pulse, and two capacitance dividers of 1.9  $\mu\text{F}$  for the measurement of grid voltages. All components of the test set were contained in one large oil filled steel tank. A circuit diagram is shown in Figure 2. A resistance divider of 10 megohms per gap was used for stabilizing grid potentials.

Figure 2: Circuit Diagram of the Test Modulator.

For testing and evaluation of the tubes, a line-type modulator was constructed which produced the specified operating condition and had the following characteristics:

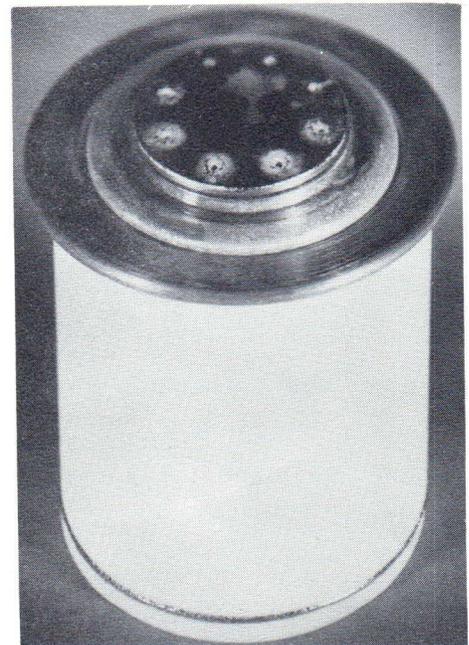
Figure 4: Anode of the same tube showing deep holes at the impact areas of the discharge. Gradient grids have eight .104" dia. holes.

Anode erosion was reduced by operating the tubes under a sufficiently high gas pressure. This was not a problem as reservoir ranges were always wide and had fairly high upper limits. Range stability during life was provided by a titanium hydride reservoir containing 2.5 grams of hydride and approximately 30 liter x millimeter of hydrogen. Tube life was greatly improved in this way since the danger of voltage breakdown across the anode gap insulation was reduced at the same time. Tube lives of several hundred hours were attained.

Defocusing of the discharge at the anode plate; that is, a reduction of current density in the impact areas, was effected by substituting two slots for the eight holes normally used in the gradient grids. Erosion in the linear marks produced with this type of grid aperture was less, and a similar result was obtained by substituting tungsten for molybdenum which was commonly used.

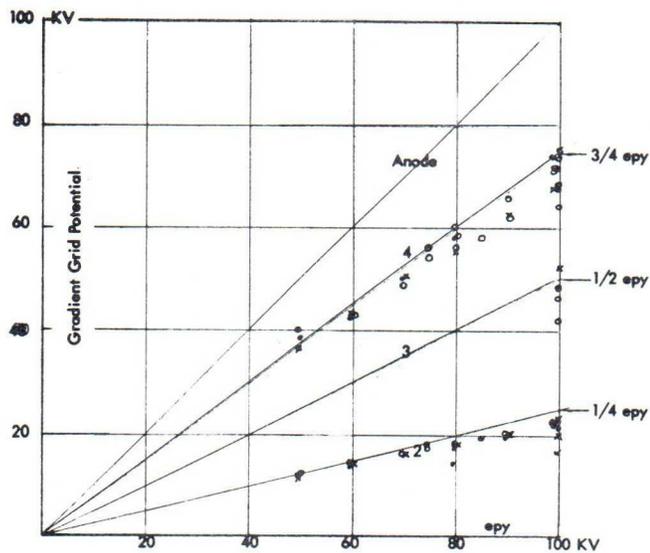
Gradient grid potentials in a four gap tube made with slot type grids are shown in Figure 5. As a general rule, all grid potentials were found to be below the voltage levels established by the resistance divider. At  $e_{py} = 100$  KV, the voltage drop across the anode gap thus amounted to some 30 KV for slot type grids, and was still larger for the other grid type. The potentials which are determined from the scope traces are attained by the grids between pulses as the network charges up. When they break down during anode take-over, commutation voltage drops of short duration must appear in the gaps which depend on the nature and timing of the anode take-over process.

Figure 5: Gradient Grid Potentials in a Four-Gap Tube.

The voltage breakdown at the anode gap, the erosion of the anode plate, and the apparent applicability of the epy-parameter in the  $P_b$ -Factor defining dissipation at the anode, suggest that high voltage drops are formed in the anode gap during commutation. A condition of this kind is possibly indicated by the potential level of the gradient grid which is next to the anode.

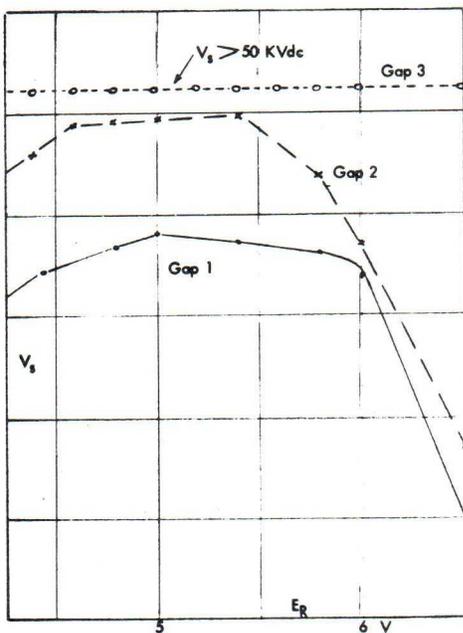
Figure 6: 3-Gap Tube.

#### Sparking Voltages $V_s$ in Three and Four Gap Tubes.

The outstanding voltage capability demonstrated by all tubes points to good sparking voltage characteristics of the gaps which were extensively investigated. Characteristics for a three and a four gap tube are shown in Figures 6 and 7. Both tubes had identical hole type grids and had been exposed to a peak forward voltage of 100 KV for about the same length of time. Sparking potentials in three gap tubes were found to be typically higher than in four gap tubes. Since comparable gaps are identical by design, and the gaps in the three gap type are exposed to higher voltage during operation, a causative relation between sparking potential levels and gap voltage drops produced by operating the tubes seems to exist.

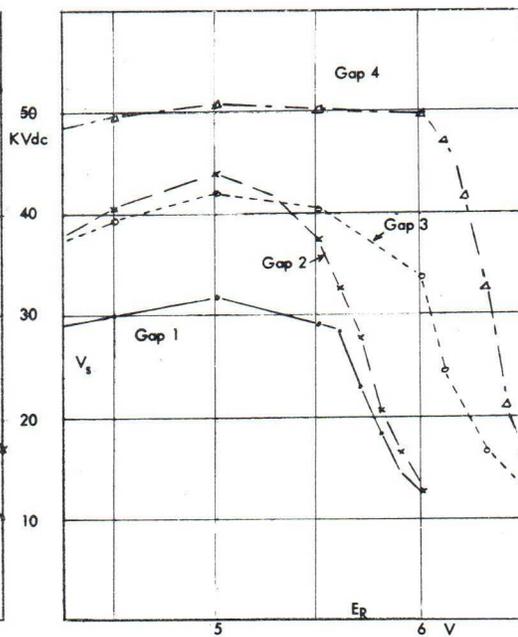
Figure 7: 4-Gap Tube.
