## DESIGN AND CHARACTERISTICS

### OF A 100 KILOVOLT HYDROGEN THYRATRON TUBE

H. E. Krefft, H. Austad, and A. E. Gordon

International Telephone and Telegraph Corporation  
Electron Tube Division, Easton, Pennsylvania

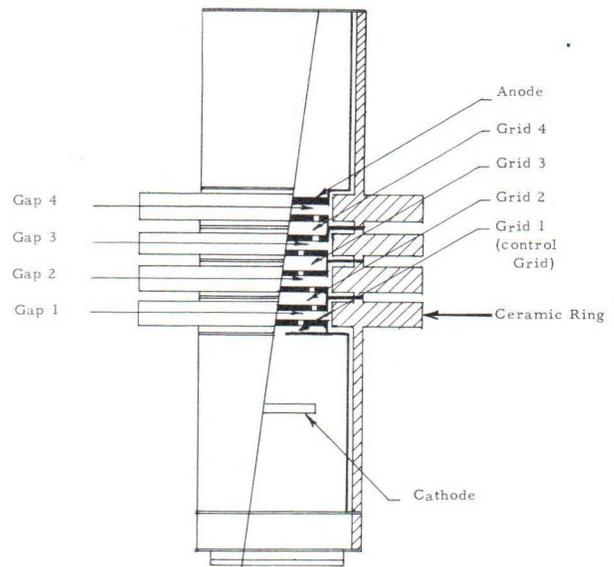
Figure 1: 100 KV - 10 KW Hydrogen Thyatron Tube. Basic design of a four-gap Tube.

The grid-envelope structure of a four-grid\* tube with four gaps consists of three planar gradient grids and four ceramic envelope rings which are brazed to the grid flanges. Voltage breakdown between seals is inhibited by internal and external extensions of the rings which internally follow the grid outlines with a small clearance. Metallic deposits originating in the gaps are formed on the cylindrical surface of the extension and are prevented from forming a continuous conducting layer between seals.

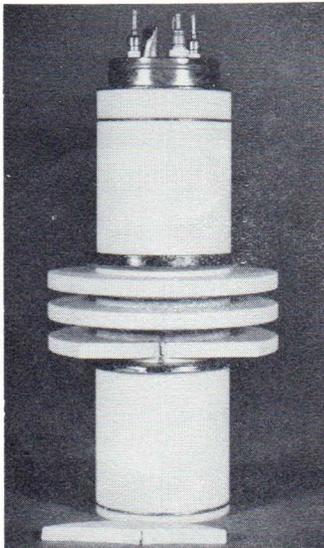
Figure 3: Three-Gap Tube damaged by voltage breakdown through the envelope ring.

Unexpectedly short lives were experienced in the beginning when operation at the specified ratings of 100 KV, 10 KW, 1000 pps and a  $P_b$ -Factor of  $20 \times 10^9$  was attempted. The anode plate was found to be strongly eroded at the impact areas of the discharge, and high voltage breakdown through the ceramic envelope extension at the anode gap became a typical cause of failure. These defects are illustrated by the photographs in Figures 3 and 4.

In spite of these measures, tube life still was terminated by voltage breakdown through the ceramic envelope ring, which resulted in a leak. In most tubes this defect was caused at the external ceramic extension of the anode gap, in one tube internally, and in two other cases the gap next to the anode gap was involved or the only one affected. Improvement of this condition was attempted by avoiding high electrical field strength at the seals, and by increasing the thickness of the external extension of the envelope ring.

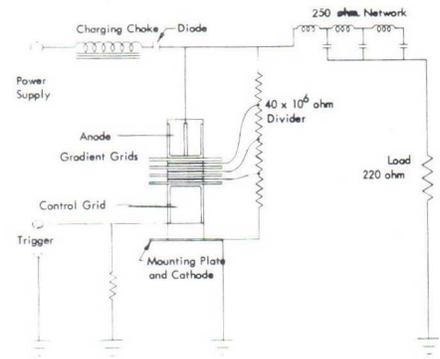
Figure 2: Circuit Diagram of the Test Modulator.

The instrumentation included a pulse transformer for viewing the current pulse, and two capacitance dividers of 1.9  $\mu\text{F}$  for the measurement of grid voltages. All components of the test set were contained in one large oil filled steel tank. A circuit diagram is shown in Figure 2. A resistance divider of 10 megohms per gap was used for stabilizing grid potentials.

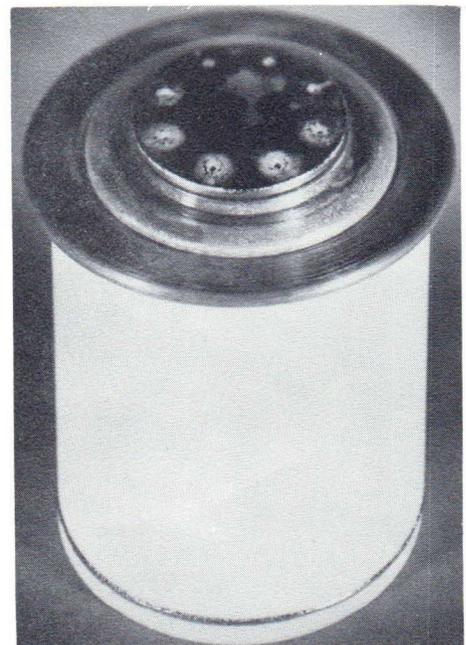
Figure 4: Anode of the same tube showing deep holes at the impact areas of the discharge. Gradient grids have eight .104" dia. holes.

Anode erosion was reduced by operating the tubes under a sufficiently high gas pressure. This was not a problem as reservoir ranges were always wide and had fairly high upper limits. Range stability during life was provided by a titanium hydride reservoir containing 2.5 grams of hydride and approximately 30 liter x millimeter of hydrogen. Tube life was greatly improved in this way since the danger of voltage breakdown across the anode gap insulation was reduced at the same time. Tube lives of several hundred hours were attained.

Defocusing of the discharge at the anode plate; that is, a reduction of current density in the impact areas, was effected by substituting two slots for the eight holes normally used in the gradient grids. Erosion in the linear marks produced with this type of grid aperture was less, and a similar result was obtained by substituting tungsten for molybdenum which was commonly used.

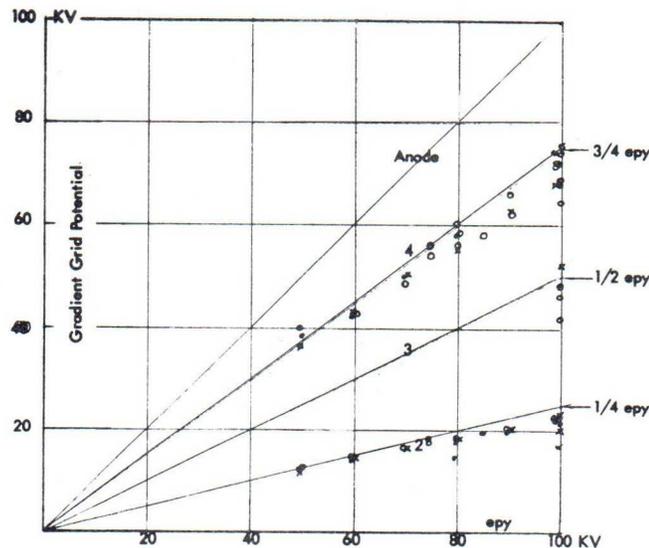
Figure 5: Gradient Grid Potentials in a Four-Gap Tube.

Gradient grid potentials in a four gap tube made with slot type grids are shown in Figure 5. As a general rule, all grid potentials were found to be below the voltage levels established by the resistance divider. At  $e_{py} = 100$  KV, the voltage drop across the anode gap thus amounted to some 30 KV for slot type grids, and was still larger for the other grid type. The potentials which are determined from the scope traces are attained by the grids between pulses as the network charges up. When they break down during anode take-over, commutation voltage drops of short duration must appear in the gaps which depend on the nature and timing of the anode take-over process.

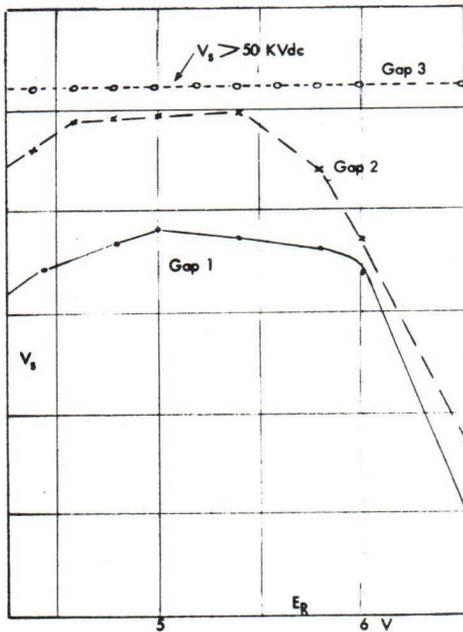
Figure 6: 3-Gap Tube.

#### Sparking Voltages $V_s$ in Three and Four Gap Tubes.

The outstanding voltage capability demonstrated by all tubes points to good sparking voltage characteristics of the gaps which were extensively investigated. Characteristics for a three and a four gap tube are shown in Figures 6 and 7. Both tubes had identical hole type grids and had been exposed to a peak forward voltage of 100 KV for about the same length of time. Sparking potentials in three gap tubes were found to be typically higher than in four gap tubes. Since comparable gaps are identical by design, and the gaps in the three gap type are exposed to higher voltage during operation, a causative relation between sparking potential levels and gap voltage drops produced by operating the tubes seems to exist.

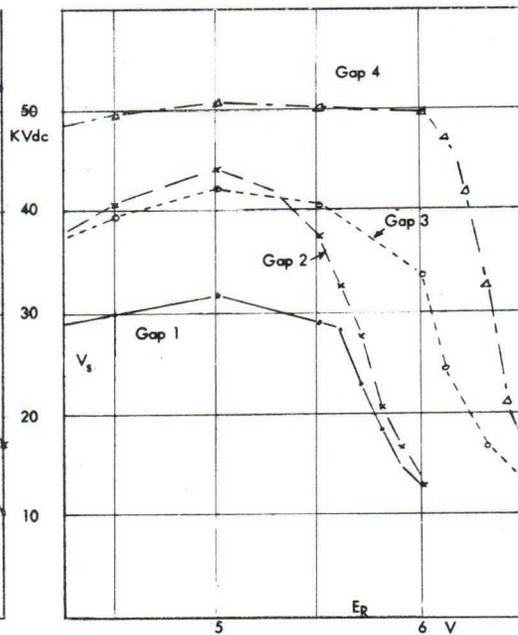
Figure 7: 4-Gap Tube.
